Fall from Height

Issue No.	002
Issue Date	27 November 2018
Issuer	IRATA Health & Safety Committee
Status	Report following operating members' reports

IRATA SAFETY BULLETIN SB39 Fall from Height

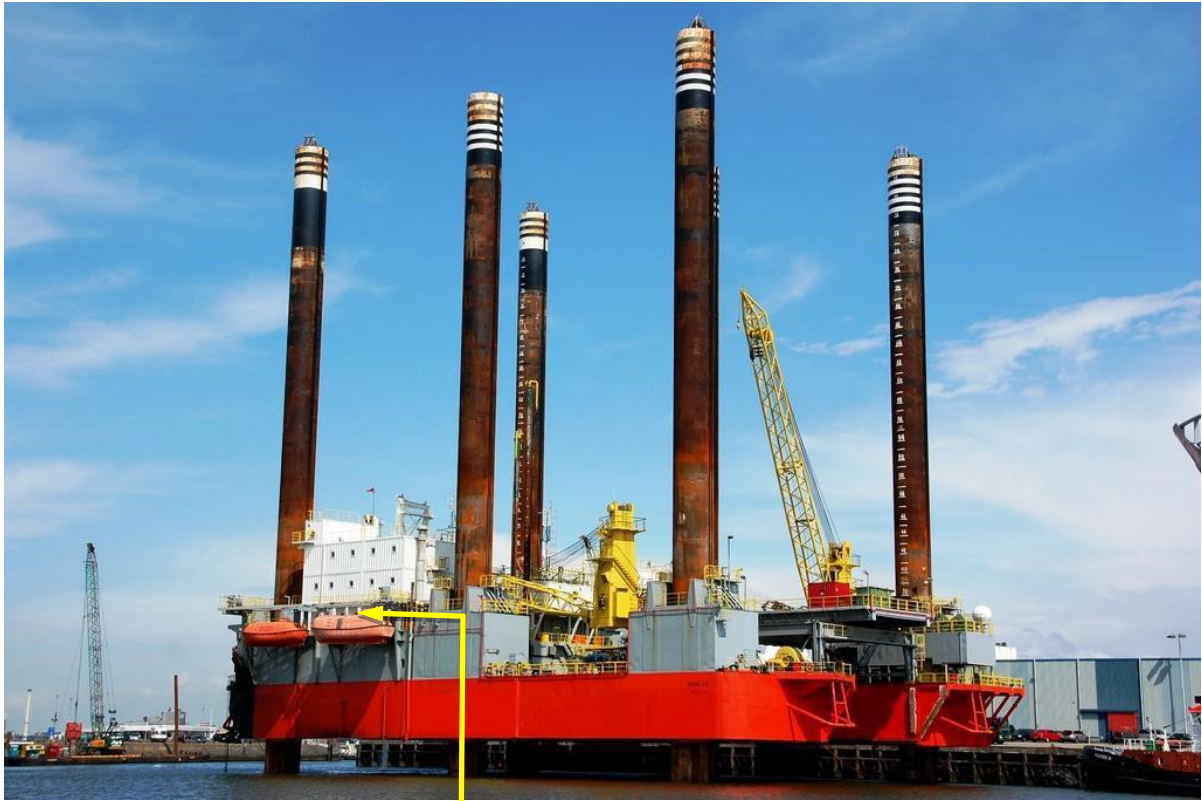
Figure 1 - position on the vessel

On 04 February 2015, in a shipyard on board a vessel, rope access work was in progress. Working space was barricaded with red/white tape, according to the procedures. NDT specialist, technician 1 (Tech 1) was performing work to the top structure (davit) of a lifeboat. He was nearly finished.

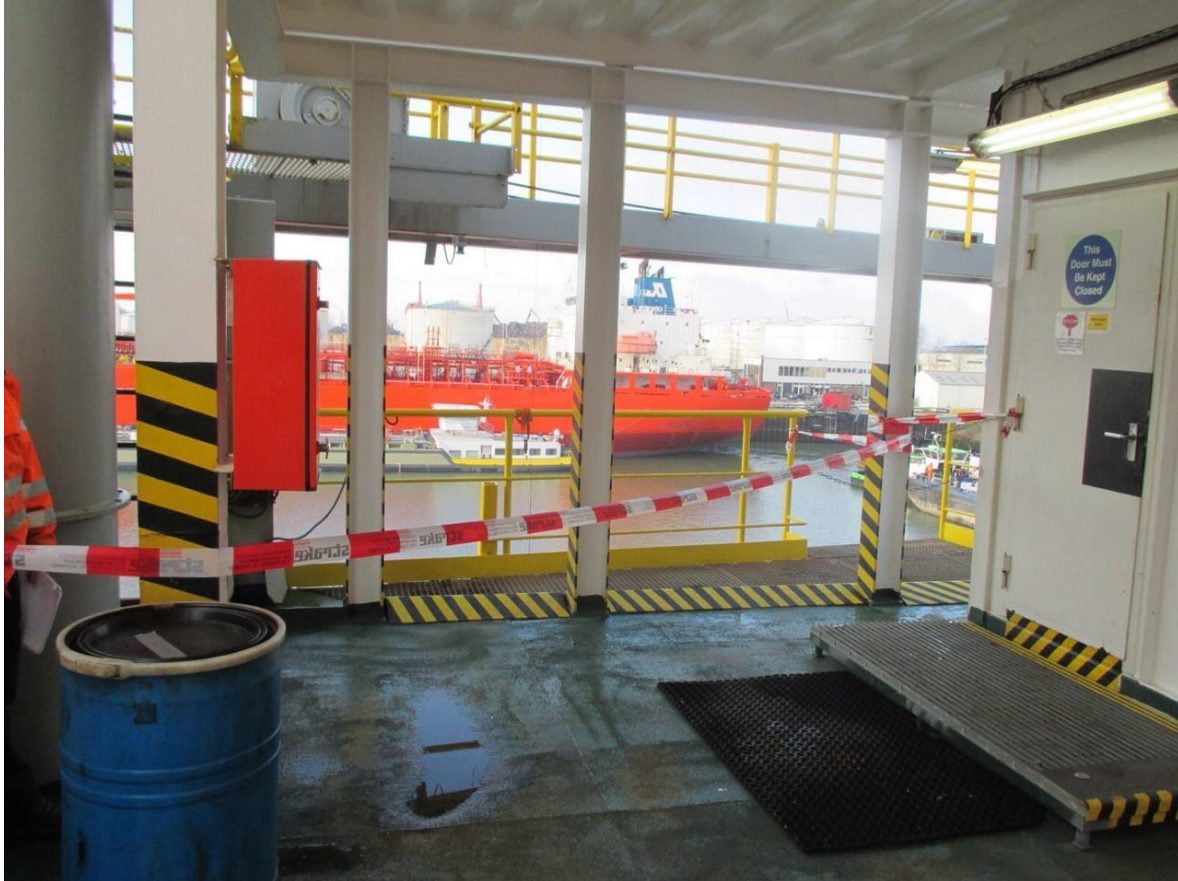
Figure 2 - Working space barricaded with red/white barrier tape

The use of barrier tape to prevent third party access was totally inadequate bearing in mind the removal of walkway grating and creating an exposed edge. This may have contributed to the overall

- Barricading off the affected area from third party access using signed and hard barriers (in this case barrier tape had been an implemented control measure and was not the immediate cause);
- Implement a Work Restraint system so that it is impossible to reach the affected area;
- The use of a barrier system around an opening as an automatic default action if any grating in a walkway is to be removed;
- Only remove walkway grating when absolutely necessary i.e. when accessing the work area to carry out the task and then installing the walkway grating as soon as the task is complete and technicians have egressed the work area therefore minimizing the exposure time to the hazard;
- If selecting fall arrest as a method of access whilst moving around the affected area then 100% attachment at all times must apply and an appropriate system selected to reflect this.

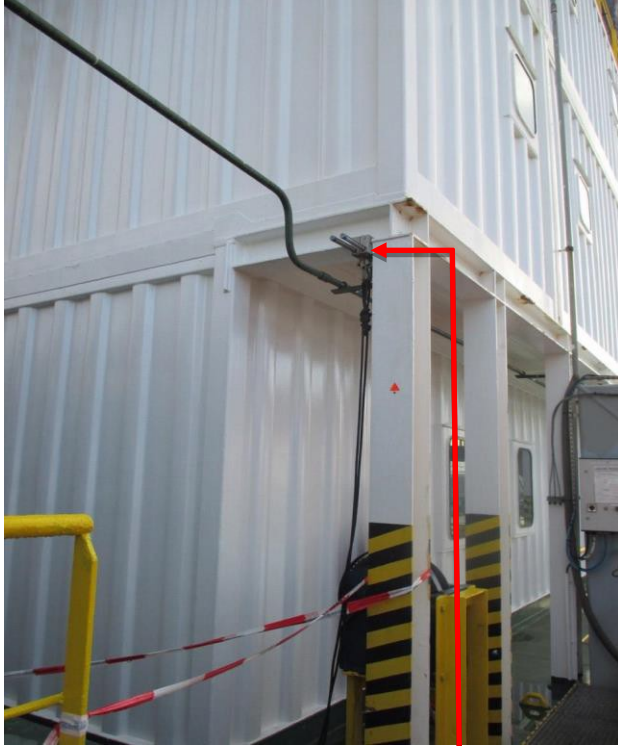
Figure 3 - Point A rigging

Tech 3 was secured with ropes from the rigging attached to beam clamps (see Figure 3, point A and Figure 4, point D).

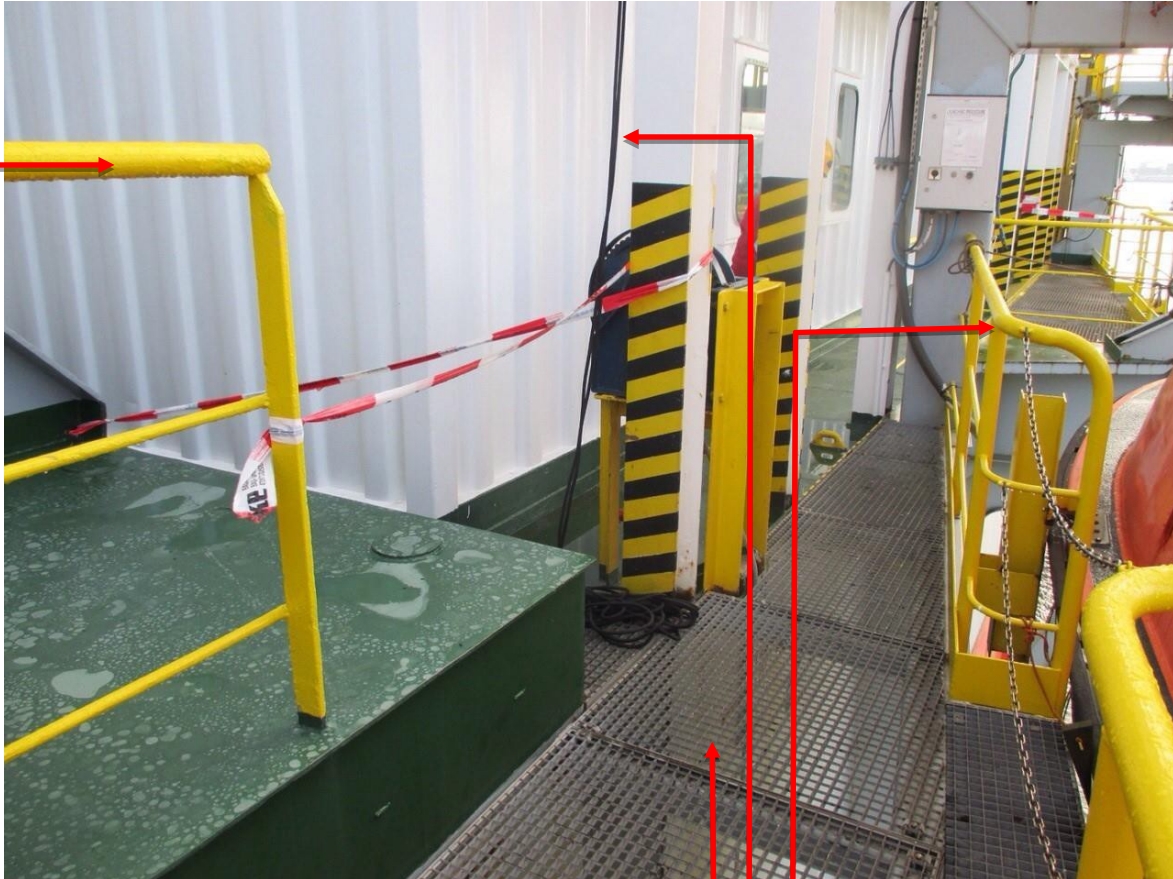
Figure 4 -:

The rope access supervisor (Tech 2) for the task was preparing the rigging with beam clamps in order to inspect the next welding spot. To gain proper access to the welding spot and to properly perform a rescue if necessary, walkway grating (see Figure 4, point B) was removed by Tech 2 and Tech 3 and placed out of the way. During this action, Tech 2 had secured himself with a lanyard to the top of the handrail (see Figure 4, point C).

Tech 2 noticed that Tech 1 had his leg near the lifeboat control panel. His intention was to warn Tech 1 to be aware of the control panel. In order to warn Tech 1, Tech 2 turned himself 90 degrees to the right in order to face Tech 1. Now Tech 2 is facing the hole in the grating. At the same time Tech 2 intended to take a different position on the grating, in the direction of Tech 1. Taking a different position, Tech 2, removed with his left hand lanyard from point C (see Figure 4), made a step with his left foot and intended to secure himself to point E (see Figure 4) with the lanyard in his right hand.

While doing these multiple maneuvers, for a split second Tech 2 was unsecured and stepped into the hole of the grating. As a result, Tech 2 fell through the opening in the walkway grating and into the water from 14 meters high. Tech 2 fell with his feet downwards into the water. When coming back to the surface the lifejacket started to inflate.

Multiple maneuvers were performed in a short time, which led to this human error from a very experienced rope access technician.

In case a lifeline / safety-line was in place, the necessity for unhooking when changing of position was not necessary and highly likely would have prevented this accident.

Point B= Tech 2 & 3 removed grating panel

Point C= Tech 2 secured with lanyard

Point D= Tech 3 secured with ropes to harness

Point E= Tech 2 intended to attach to new point with right hand

□□□□□ will adjust the RA-OPS (Rope Access procedure) with an additional paragraph explaining the procedure what to do with unstable or open surfaces and/or grating. In detail will be explained that in case of open surfaces, lifelines / safety-lines will be placed along the open surfaces. Lifeline / safety-line will be fastened to proper anchor points. In case a lifeline / safety-line will be in place, the necessity for unhooking yourself when changing of position in case necessary, is limited.
