## Safety Bulletin No. 45

### **SAFETY BULLETIN NO. 45: FALL FROM HEIGHT: AID CLIMBING**

*A safety bulletin aimed at raising awareness of hazards in the rope access industry. The text may be of use as part of a toolbox talk.*

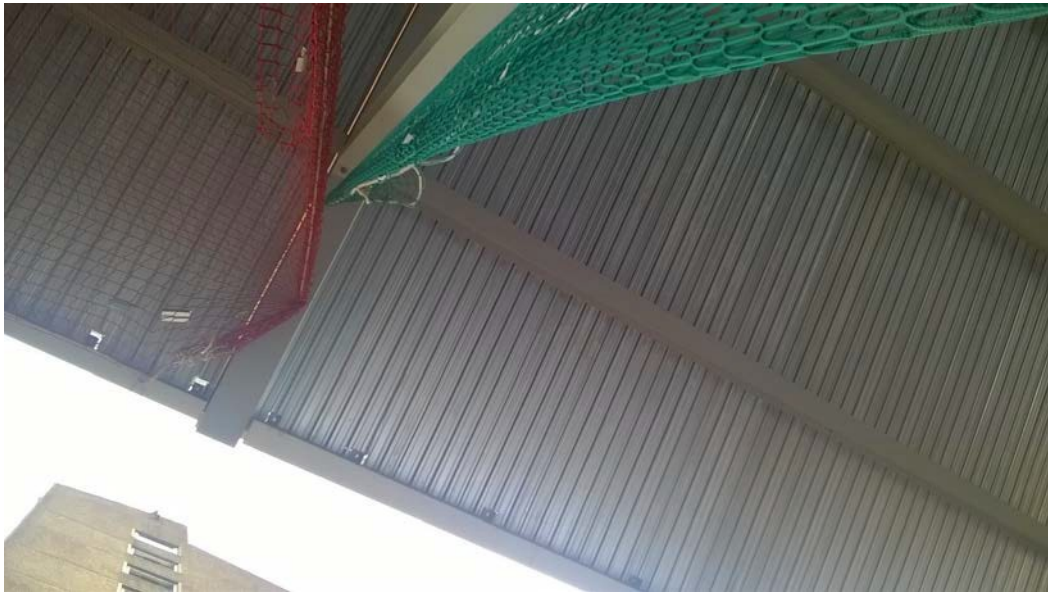
**Photo 1:**

- 3.2.5 **First accident:** When the end of a beam was reached it was necessary for the technician to reposition themselves on the other side of the steelwork connection, so that de-rigging could continue. In order to do this, and to attach their third beam glider to the bottom flange in the adjacent span, he needed to lean across and release the first safety net anchor. This involved grabbing the rigged safety net - which had some tension in it - and pulling it towards him.

First accident: Look upwards at the area to be de-rigged (left) and the area that had just been de-rigged.

The width of the bottom flange reduces from 200mm wide (right) to 150mm wide (left). The depths of the beams were also different.

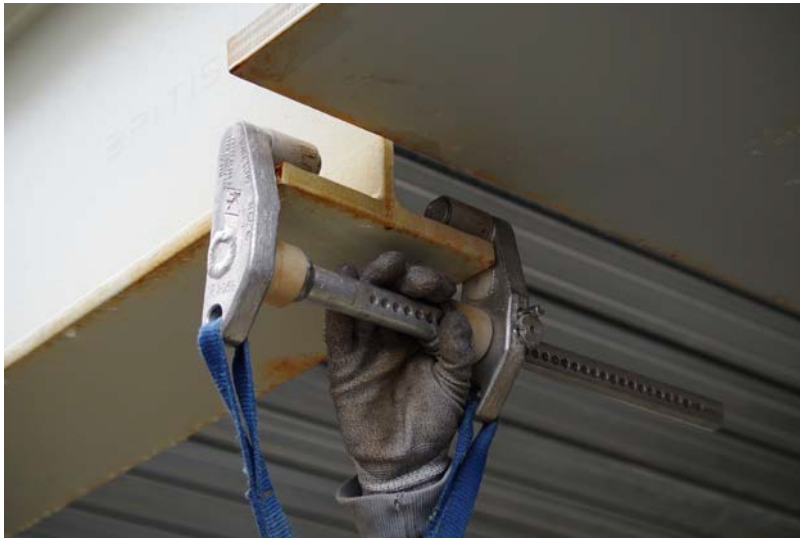
**Photo 2:**

- 3.2.6 There was a gap between the bottom flange of the beam and the flange of its connecting column. This dimension was such that it did not prevent the wheels on the beam glider passing through it. Thus, this resulted in the technician falling from height when losing both his primary support and back-up when the beam gliders were pulled off and/or fell off the open end of the bottom flange (see **Photo 2**).

First accident: Beam glider at open end of beam (37mm wide gap) [Reconstruction]

- 3.2.7 It appears that the equal and opposite horizontal reaction had not been recognised; and the direction of loading was no longer purely vertical.
- 3.2.8 **Second accident:** The technician, using three beam gliders, was travelling along the steel beam and did not identify an open-ended bottom flange, where two beams met. He pulled himself past this gap, which resulted in the primary and back-up support being lost and a fall occurring.

- (a) designing the steelwork in such a way as to eliminate or substantially reduce open ends or cut outs; or if these are necessary;
- (b) introducing cleats or 'man locks', for example, that would prevent a beam glider leaving the steelwork (see 3.3);
- (c) considering the use of locking beam gliders which can be clamped to prevent unplanned movement;
- (d) ensuring a thorough pre-start check is carried out to identify any open-ended steelwork from the ground before gaining access at height.

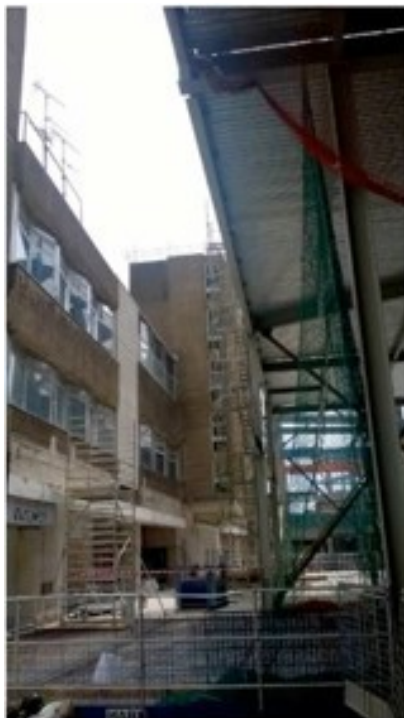
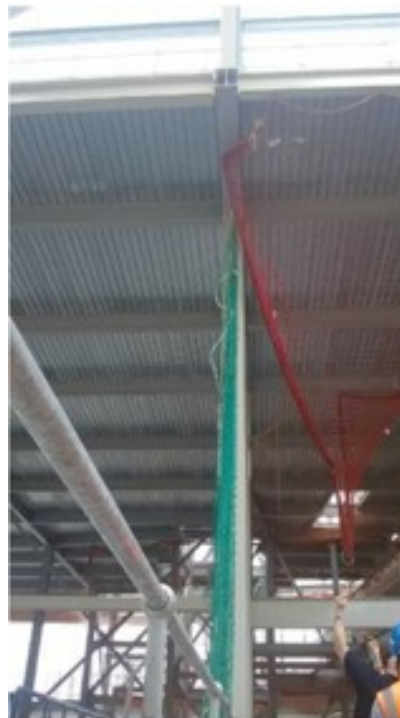
**Photo 3:**

The location of the fall in one of the incidents
